CPED STAFF REPORT

HPC Agenda Item #6
July 14, 2015
BZH-28248

Project Name: 404 West Broadway and 410 West Broadway

SITE OBSERVATION REPORT

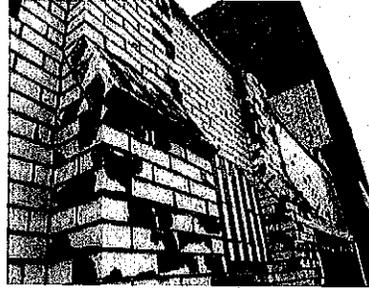
1. Several areas of the glazed brick on the front wall have lost their glazing and mortar joints. This has predominantly occurred at the upper half of the wall elevation. Open mortar joints allow water infiltration which deterioration of the wall from the inside as well as spalling of the brick and additional mortar during freeze/thaw cycles.

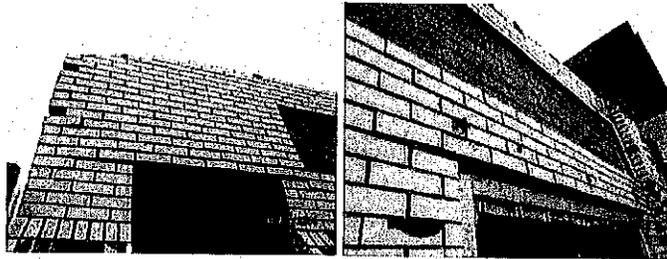
2. The brick over the two western window openings appears to be projected outward from its original position.

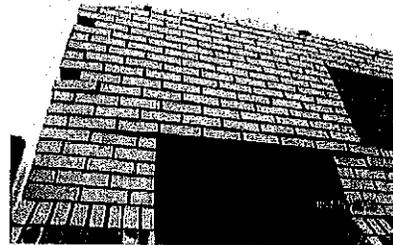
3. The brick over the western most window opening shows signs of settlement via the stepped cracking of the mortar joint.

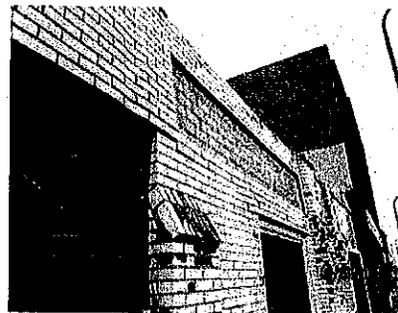
4. The upper portion of the front wall appears to lean towards the rear of the store. An out-of-plumb offset to this degree indicates a failure in the structure.

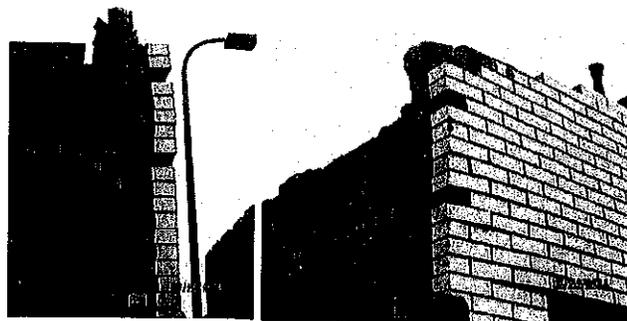
5. The southwest building corner consists of two brick walls abutting each other. Deteriorated and/or missing mortar joints and bricks along with improper/missing flashing allows for infiltration of moisture into the building.

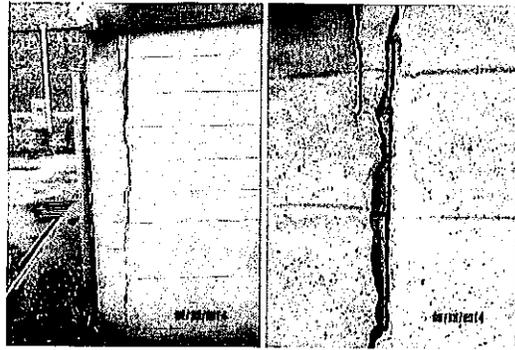
6. The northwest corner of the structure is failing at an improperly constructed control joint. The placement of wood in the joint has allowed moisture to penetrate the wall and cause damage.

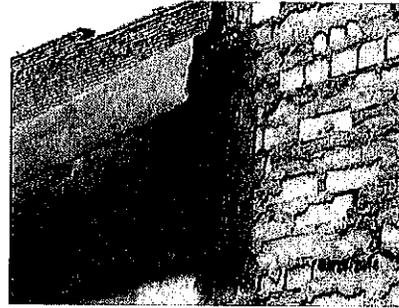
7. Signs of failed attempts to prevent moisture from entering the structure.

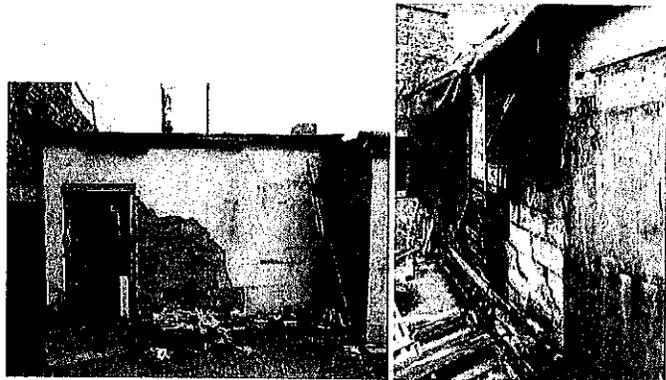
8. The rear wall is in poor condition. The existing stucco finish is falling off and concrete block mortar joints are deteriorating. The area of clay tile, adjacent to the rear door, is unstable and deflects when putting pressure on the door.

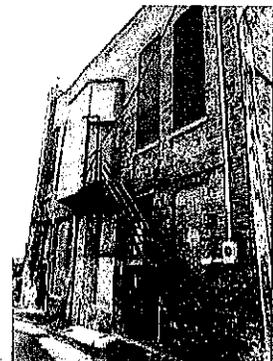
1. Several locations on the south elevation require stucco and brick repair.
2. Brick at the northeast corner appears to have experienced major deterioration along with an unprofessional repair.
3. The fire escape stair extending down from the second floor along the rear wall is loosely connected to the building and structurally unstable.

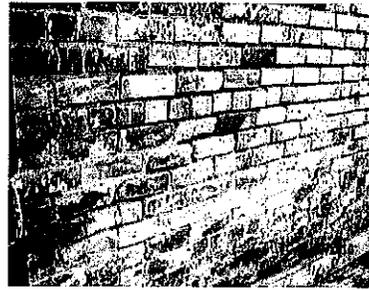
4. Several areas of brick along the west elevation require repair of the mortar joints.

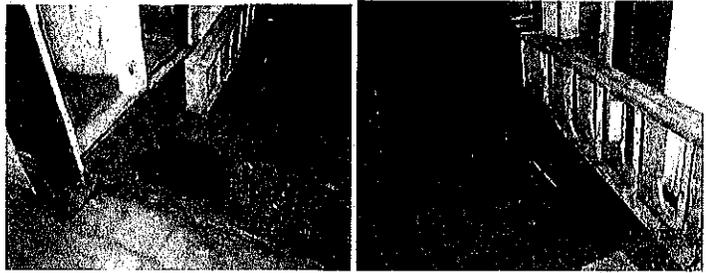
8. Areas of standing water on the second and first floors.

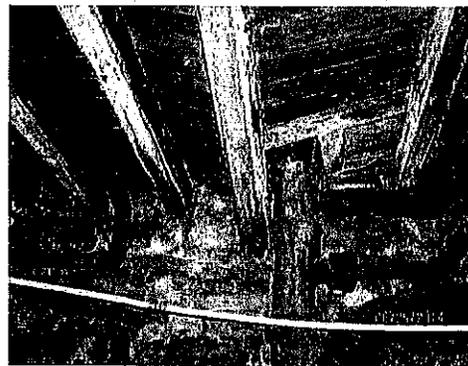
10. Deterioration of ground floor framing at perimeter foundation wall due to moisture on non-moisture treated lumber. Also, failure of floor member creating sloped floor.

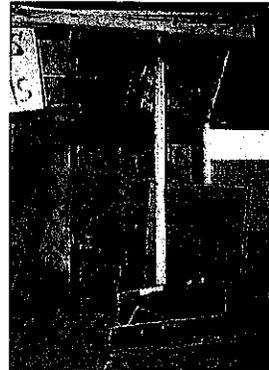
13. Shoring of ground floor framing at south end of building.

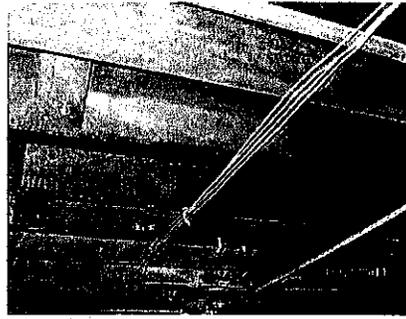
16. Existing moisture saturated ground floor framing.

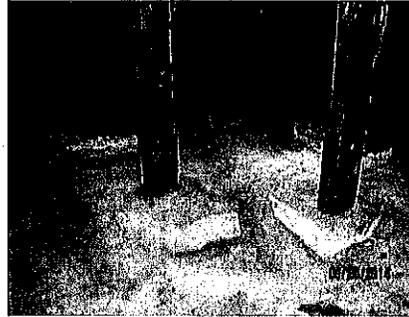
17. Existing shoring of ground floor framing at south end of building. Placement of posts and framing detailing appears to not have been engineered.

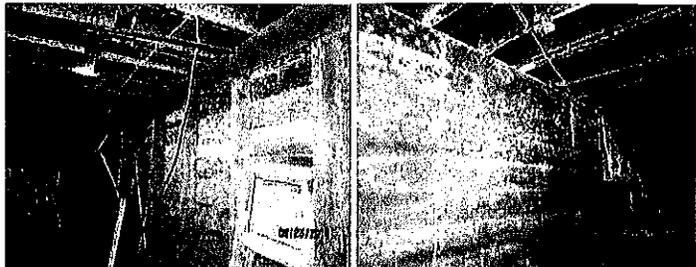
19. Existing mold on underside of ground floor framing and basement wall framing due to excessive moisture.

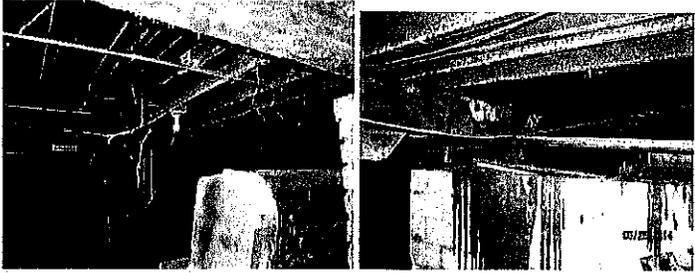
<p>20. Additional excessive moisture and mold on underside of ground floor framing and basement structure.</p>
