MINNEAPOLIS POLICE DEPARTMENT (MPD) - SUPPLEMENTAL OBSERVATIONS

October 24, 2023

This **Supplemental Observations** document is being provided to Minneapolis Police Department (MPD) as an additional resource prior to completion of the Facility Condition Assessment (FCA) deliverables, as defined in the McKinstry Agreement with MPD.

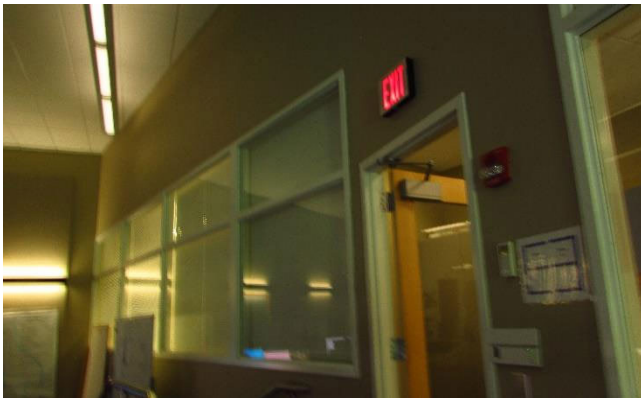
On Site Staff indicated that due to the potentially sensitive nature of material displayed on monitors/screens in Rm 131 SRC (the 'Pit') that the interior window in Rm 128 Conference Room and Rm 131 SRC (the 'Pit') needs to be eliminated (despite the existing vertical blinds).

Interior Window that Staff Would like Removed

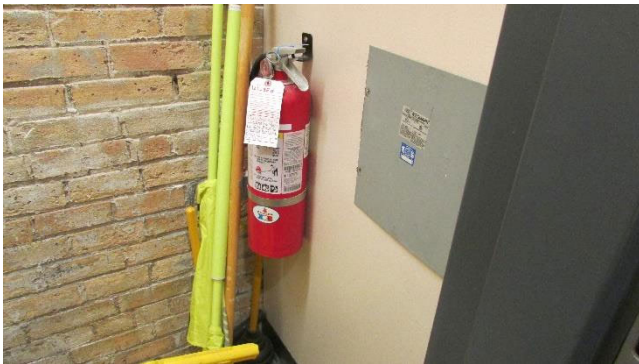
Although there are a variety of different types of fire extinguishers located throughout the facility, some are located inaccessible because they are in locked janitor's closets. These should be relocated for general accessibility. Additionally, CO₂ fire extinguishers should be installed near electronic equipment.

Fire Ext. Located in Locked Rm 107 – Janitor's Closet

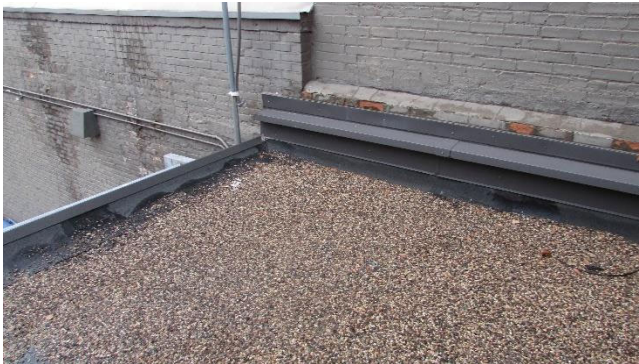
There is no safety rail near leading edge of roof for maintenance of exhaust fans and chiller on the lower roof. It is recommended that a safety rail be installed.

Lack Of Safety Rail on Leading Edge of Lower Roof

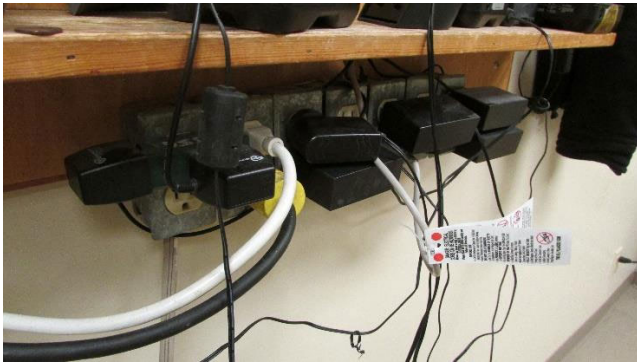
Power strips are also used extensively in the Men’s locker room to plug in radios and other essential equipment. Highly recommend that additional safety measures and education on the dangers of electrical power strips located within proximity of water.

Overloaded Outlets in Men's Locker Room

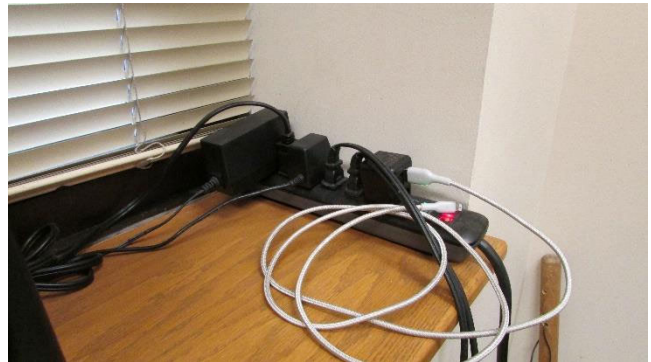
During the on site evaluation it was observed that many power strips are used, and in some instances, power strips are plugged into power strips. On site Staff indicated that circuit breaker have had to be reset in the past. Recommend evaluating essential devices compared to non essential devices that need to be plugged in.

Extensive Use of Electrical Power Strips

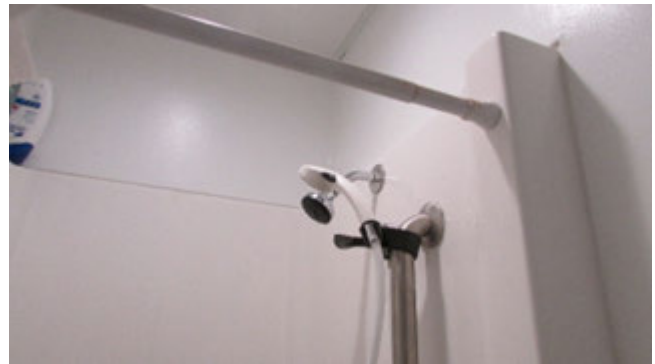
Limited Shower Availability in Precinct

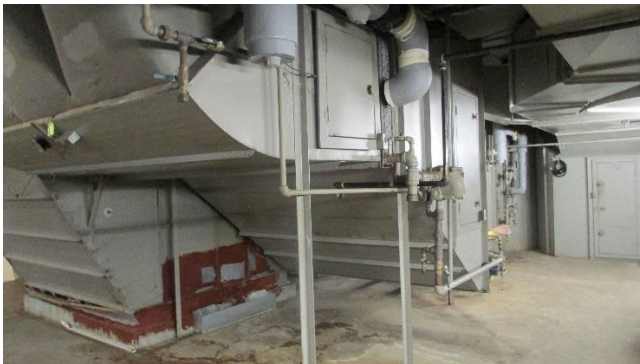
Ventilation Design Evaluation for Two (2) CV/DD Units

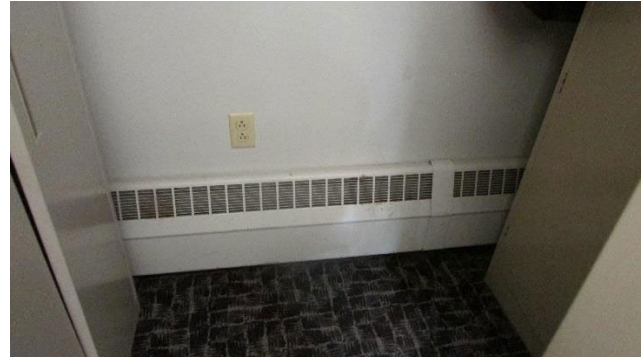
2nd Floor cubicle partitions are pressed up against the fin tube radiation on the exterior walls, significantly reducing the effectiveness of this heating source and making it nearly impossible to maintain. According to Staff, the condensed exhaust from basement mechanical room freezes during the winter causing a large amount of ice buildup on the roof directly above the pedestrian door into the Rm 132 – Garage. Potentially falling ice is a safety concern during the winter.

2nd Floor Cubicles Against Fin Tube Radiation

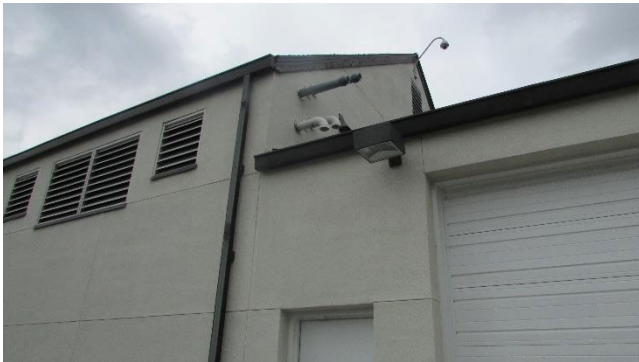
Ice Build Up During Winter Over Ped Door to Garage

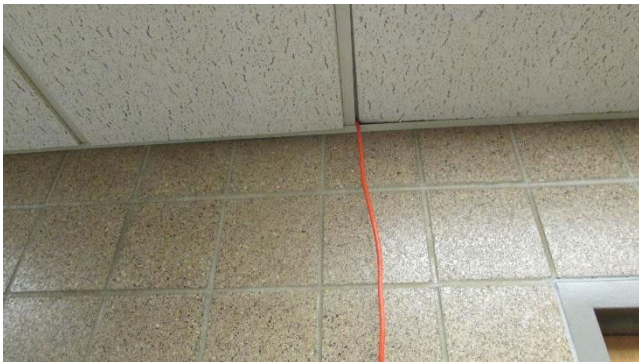
As a result, residential style dehumidifiers have been placed in these two (2) rooms and have been plugged in using extensions cords that extend above the storage room walls and below the acoustical tile ceiling and then plugged into the outlets in the adjacent corridor. During exceptionally humid conditions, the dehumidifiers fill up more rapidly and don't get emptied on weekends/off hours. It is recommended that alternative(s) be evaluated to ensure adequate ambient conditions are met within these two (2) rooms and that all applicable codes/standards be applied to these potentially hazardous condition spaces.

Extension Cords Thru Ceiling to Dehum. in Ammo Rms

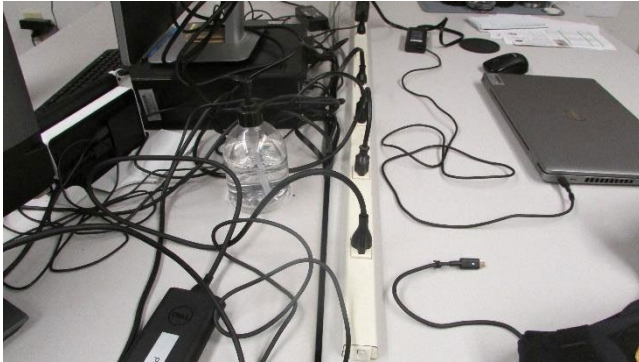
During the on site evaluation it was observed that many power strips are used, and in some instances, power strips are plugged into power strips. Recommend evaluating essential devices compared to non essential devices that need to be plugged in.

Extensive Need/Use of Power Strips

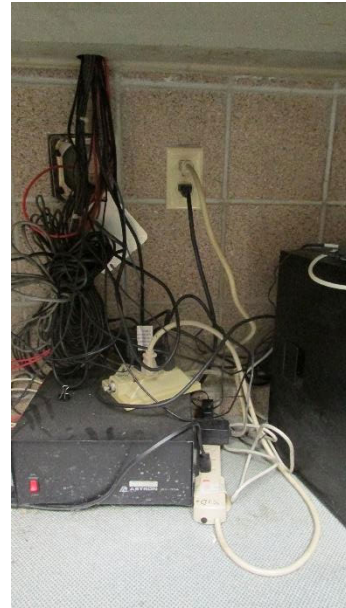
Power Strips Plugged into Power Strips

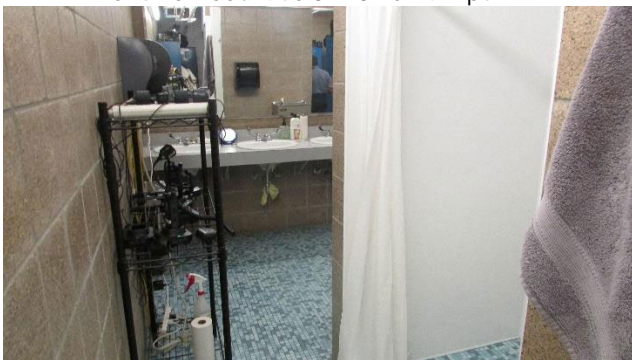
During the on site evaluation, a power strip was observed laying on floor in Rm B04 – Women's Locker Room within approximately 2 ft of the shower. We elevated this power strip off of the floor and moved it away from the shower and fastened it to a nearby shelf with a plastic tie wrap as a temporary measure. Highly recommend that the entire shelf of electronic equipment directly across from the shower be relocated and additional safety measures and education be held on the dangers of electrical power strips located within proximity of water.

Electronic Eq Directly Across from Shower in Lkr Rm

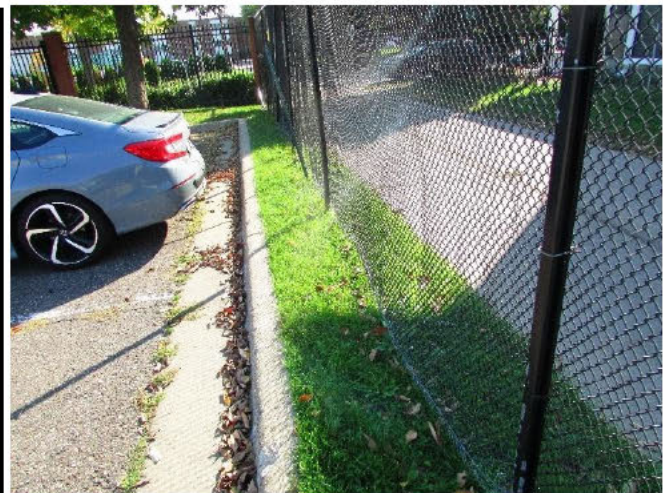
On site Staff indicated that they would like to see an element of screening installed on the perimeter fence.

Perimeter Fence Desire for Screen to Be Added

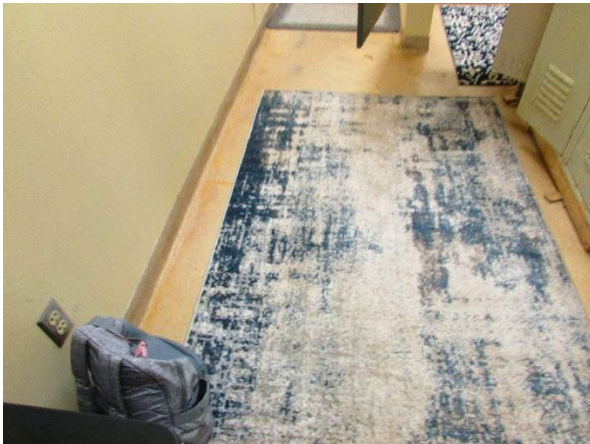
Rm 106 – Women’s locker room is half the size of the Men’s locker room with minimal space for any type of storage, seating and to move around.

Women’s Locker Room Size

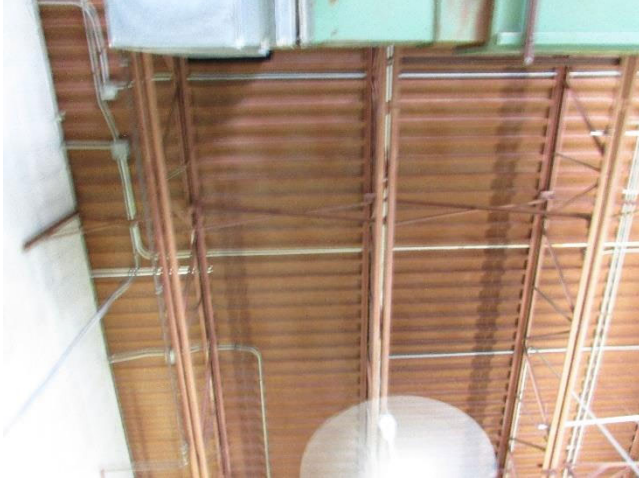
On site Staff indicated, and also showed on site evaluation Team that a fine red dust/paint from the ceiling in Rm 115 – Garage is falling from the ceiling and getting on the vehicles while performing work. Per on site Staff it's conceivable that this could contaminate forensics evidence. It is recommended that options be explored including painting the ceiling after ceiling surface treatment/cleaning is completed.

Rm 115 – Garage – Red Dust Falling from Ceiling

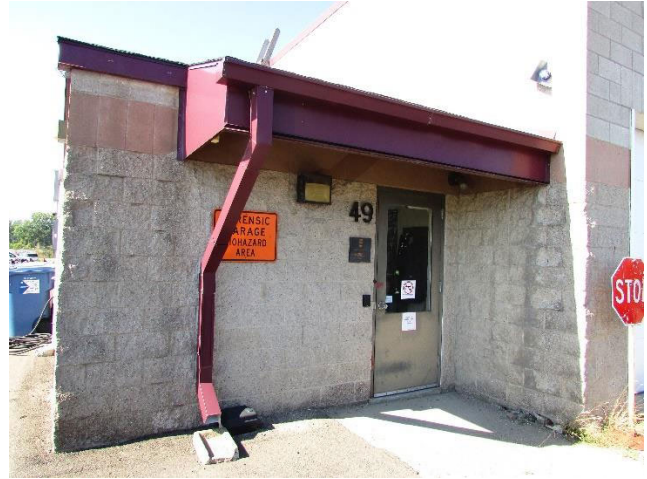
On site Staff indicated that in Winter there is accumulation of ice near the main door. As one remediation effort, it is recommended that the overhang downspout be redirected to the Southside of the building, away from this main entrance.

Ice Accumulation in Front of Door During Winter

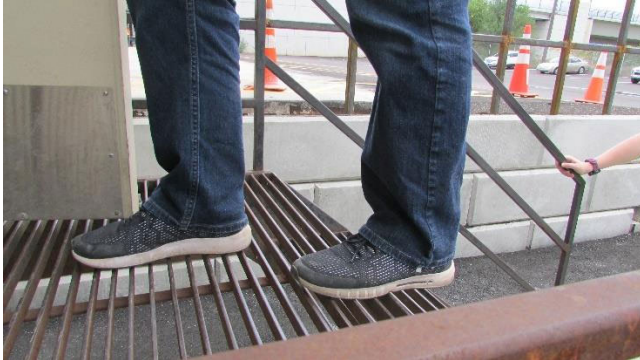
Steps into facility from rear (East) parking lot are slippery and rather small providing difficulty when carrying boxes, etc. into facility. Short landing at top prevents safely opening door outwards.

Rear Stairs Size Preventing Safe Opening of Door

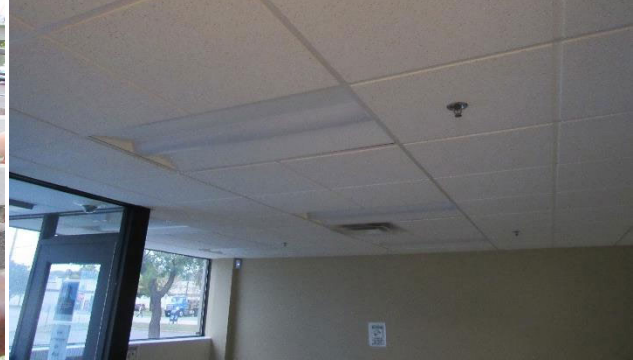
Public lobby lighting is not controllable by on site Staff. If a member of the public comes in outside of the time period in which lighting is enabled in the lobby, on site Staff is unable to turn on the lights.

Public Lobby Ltg Off, Uncontrollable by On Site Staff

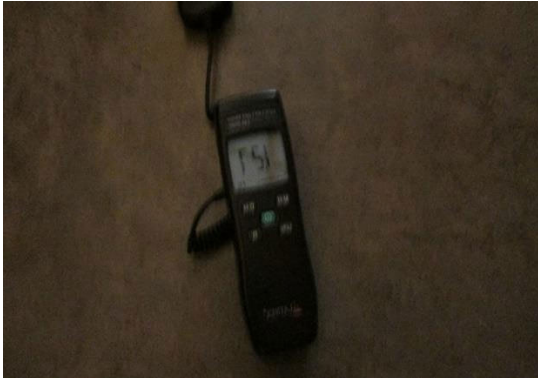
Various locations have lighting levels as low as 1.3 fc which is insufficient for sorting and storing evidence. Extend or add in lighting in various locations (near elevator, as well as room 112).

Low Level Ltg in Warehouse: 1.51 Fc Recorded

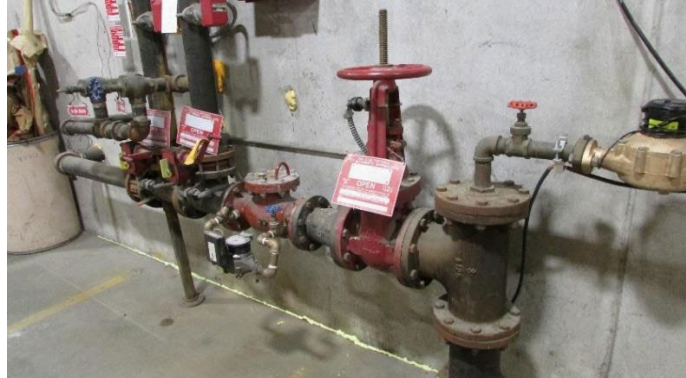
Single 6" water supply serves both potable water and fire sprinkler systems. Inadequate to provide water pressure sufficient to have taller storage racking.

6" Water Sup Srvs Potable Water/Fire Sprinkler Systems

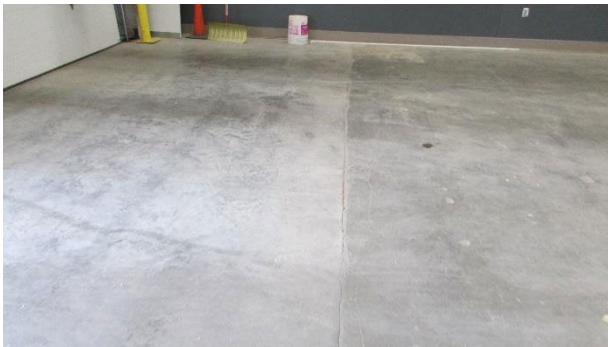
Garage drainage leads towards building center rather than outside. Sloping outward would provide better drainage.

Garage Bay Drainage Sloping Inward

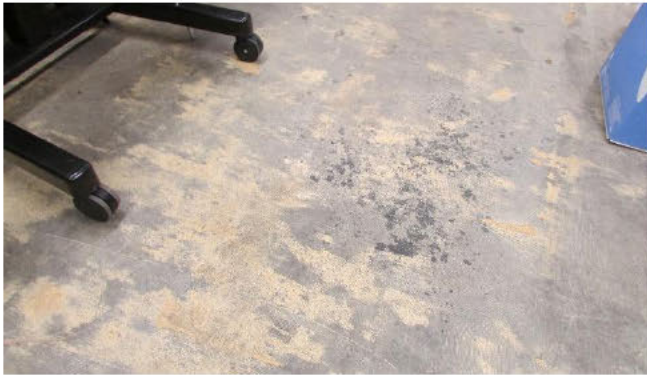
Rm 105 – Training Storage – Missing VCT

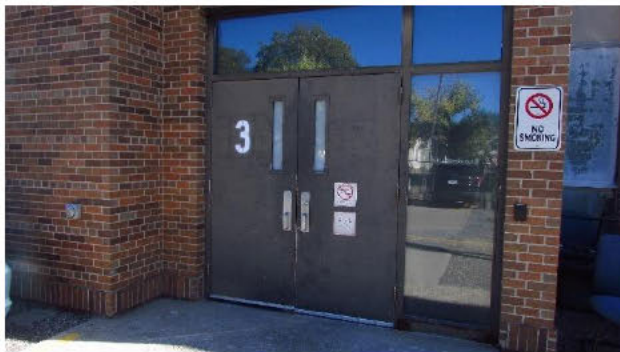
Accessible Entrance No Signage

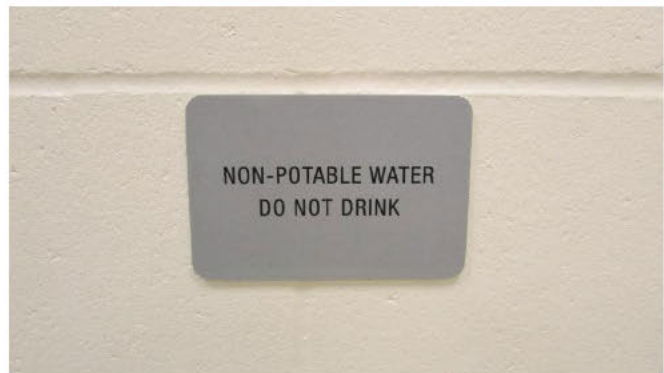
Non Potable Water Warning Signs

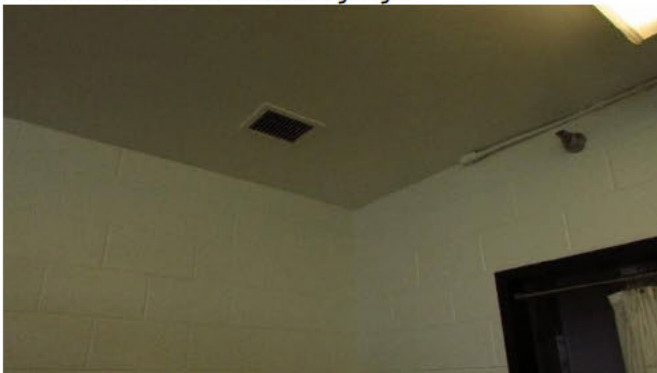
Rm 217 Women's Locker Room Airflow Issues

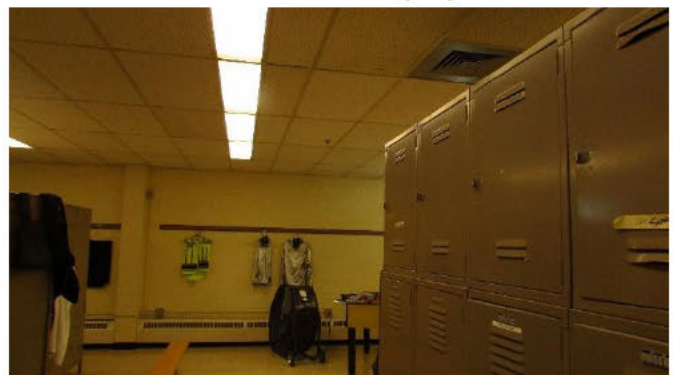
Insufficient Exhaust in Rm 206 and Rm 207

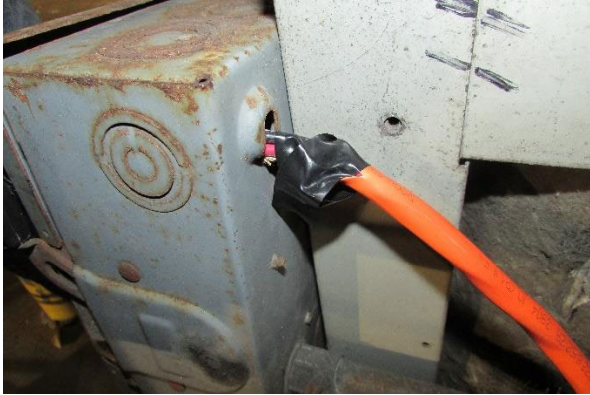
Electrical Installation for (Presum.) Cond Unit (Pic 1)

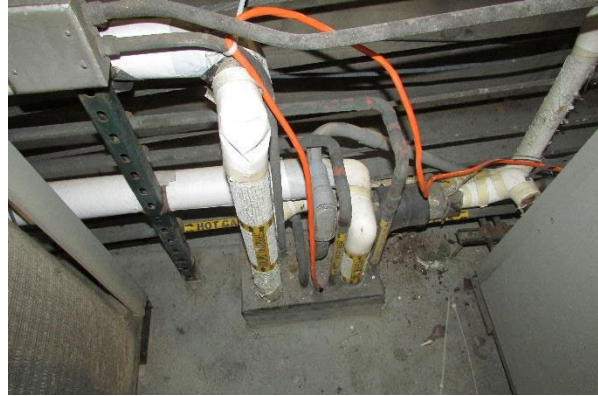
Electrical Installation for (Presum.) Cond Unit (Pic 2)

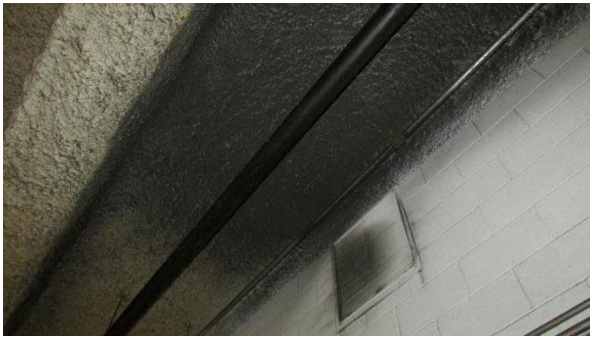
Garage Area: There is a black residue that is/has been expelled from (presumably) exhaust fan(s) located on the upper North wall of the Garage. The source of this black residue needs to be evaluated further with corrective actions performed to prevent from accumulation into the garage where occupants are located.

Garage: Black Residue (Presumably) From Exhaust

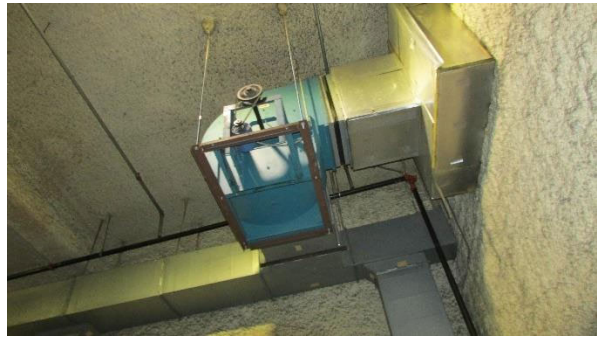
Garage Area: The primary exhaust fan was operating during the time of the on site evaluation, however there are no provisions for CO or NO₂ emissions monitoring necessary to control ventilation systems to purge this enclosed garage area. It is recommended that the entire ventilation system including the MAU unit be evaluated to ensure complete ventilation effectiveness.

Garage: Existing Garage Exhaust Fan

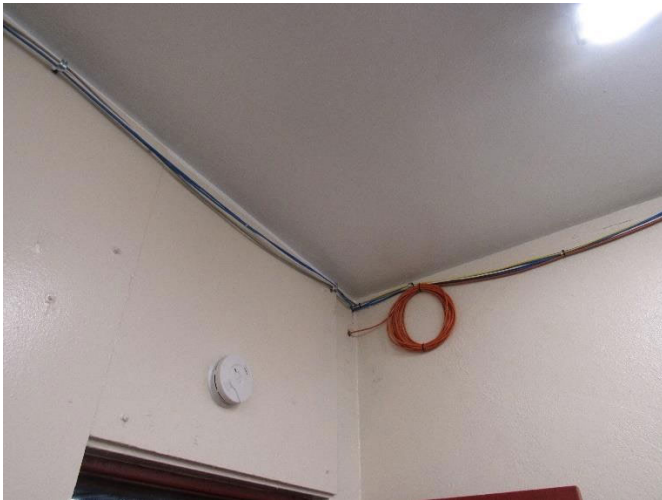
There is limited fire detection / notification for the facility, only a couple of battery operated smoke detectors, which are currently non functional.

Battery Powered Smoke Detectors
