# Evaluation of Vertical Lane Separation Treatments at In-Lane Bus Stops

# Executive Summary

## Overview

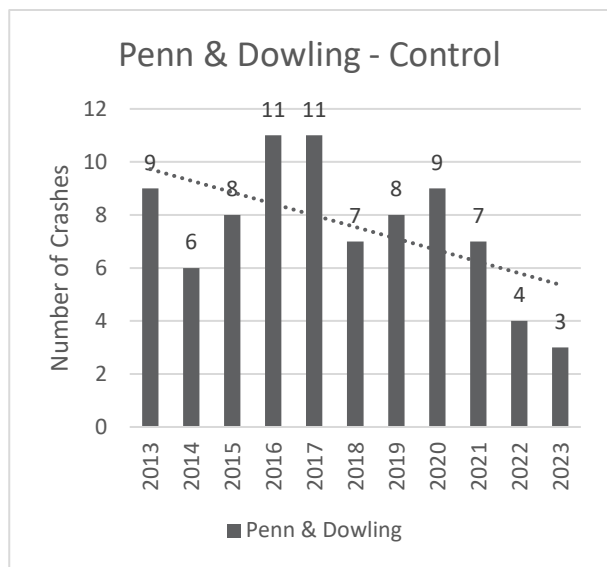
**Figure 3: Crash frequencies at control intersections**

As shown in Figure 3 above, crash frequencies at the control intersections peaked in 2017 – the year before construction for C Line began (2018). Crashes decreased in 2020, the first full year of C Line operations, compared to 2017. Since 2020, crashes have been consistently decreasing at the control locations through 2023.

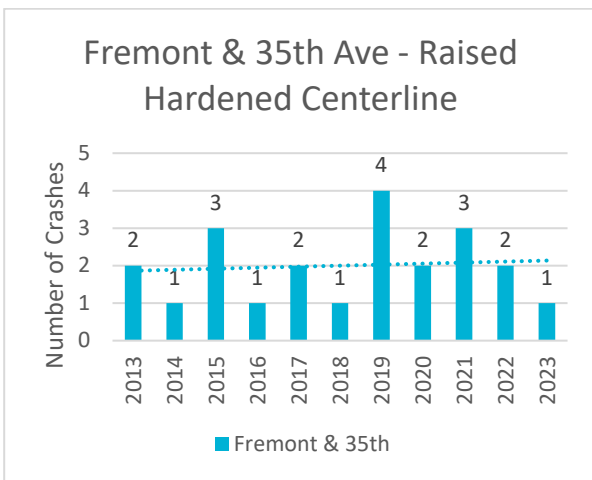
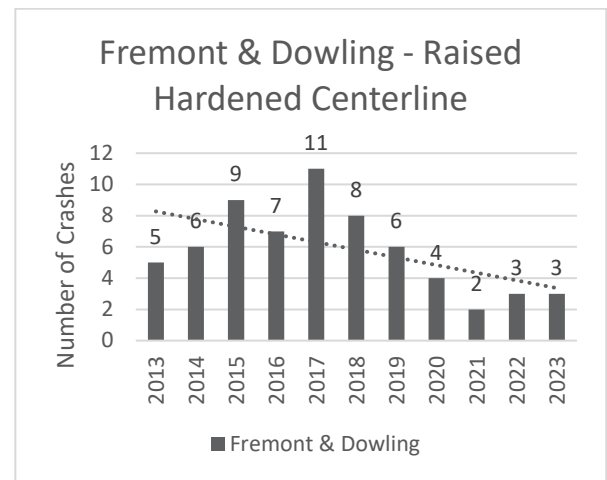
**Figure 4: Crash frequencies at study locations with raised hardened centerlines**

Raised hardened centerlines were installed along Fremont Ave N in fall 2021 and along Grand Ave S in fall 2022. As shown in Figure 4 above, Fremont & 35<sup>th</sup> Ave has seen a decrease in crashes since the installation of the raised hardened centerline. Fremont & Dowling and Fremont & 42<sup>nd</sup> Ave both saw little to no change in the number of crashes after the installation of the raised hardened centerline. Grand & W 34<sup>th</sup> St did not have any crashes the 2 years leading up to the installation of the raised hardened centerline and has not had any reported crashes since the installation.

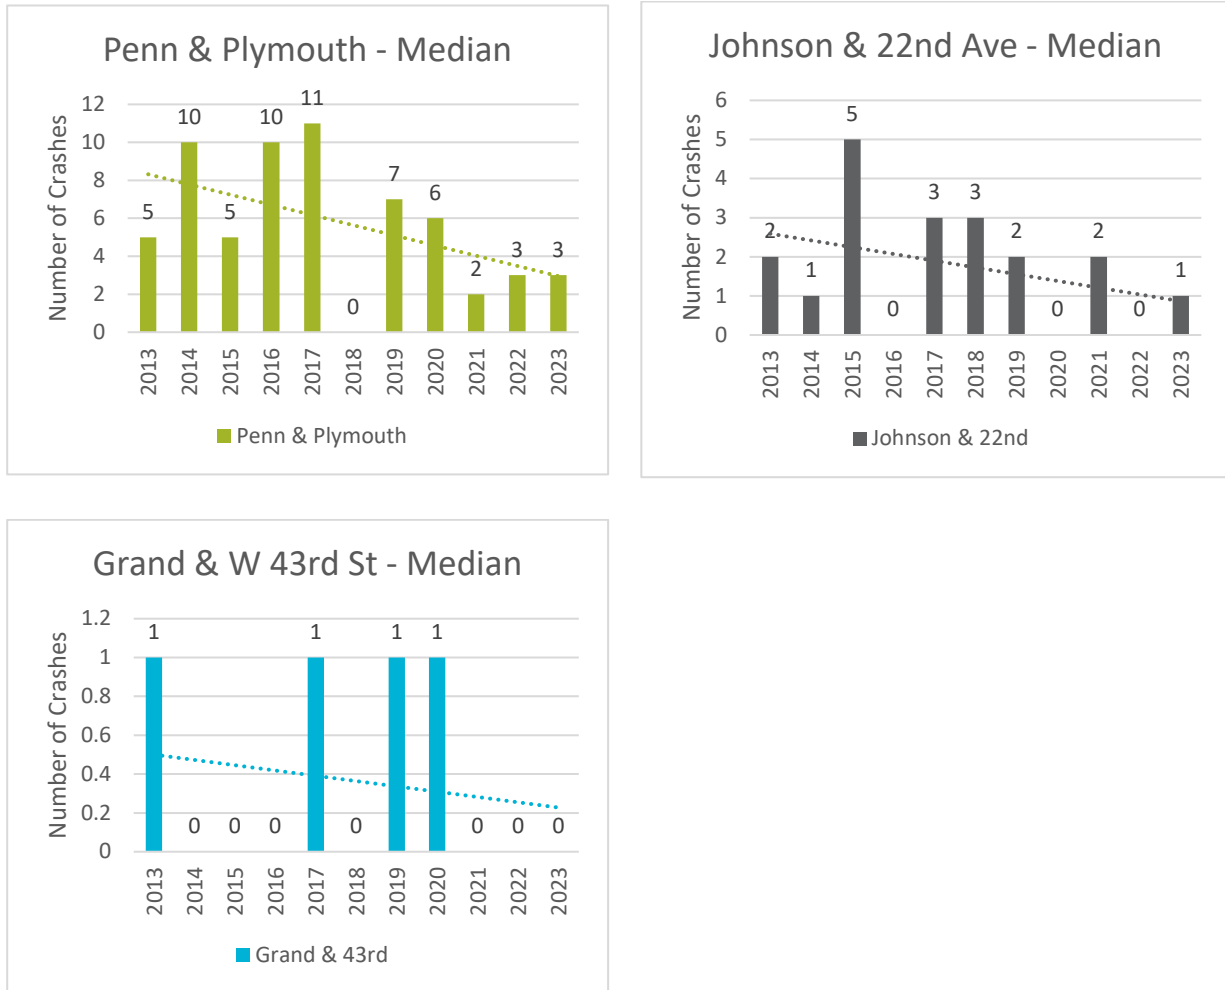
**Figure 5: Crash frequencies at study locations with medians**

Medians were installed at Penn & Plymouth and Johnson & 22<sup>nd</sup> Ave in 2021 and at Grand & W 43<sup>rd</sup> St in 2022. The medians at both Johnson & 22<sup>nd</sup> Ave and Grand & W 43<sup>rd</sup> St were both installed as part of larger corridor reconstruction projects. As shown in Figure 5 above, crash frequencies at study locations with medians all saw a decrease in crashes in the years after the installation of medians.

The study location of Penn Ave N and Plymouth Ave N is particularly interesting, because C Line improvements were installed in 2018-2019 at this location but the median was not installed until 2021. There was a slight decrease in crashes after improvements were made in 2019 with the C Line. Crashes reduced by approximately 50% when comparing post-C Line improvements and after the installation of the median.

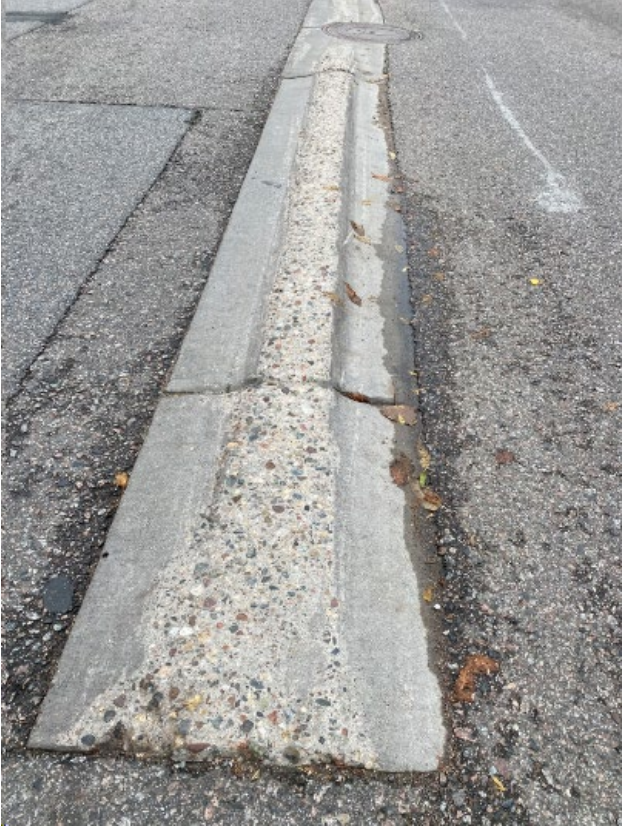
- Snowplow blades have scraped away the top of the concrete of some raised hardened centerlines causing damage to the concrete.

- The concrete of the raised hardened centerlines is being damaged by plow blades, shown in Figure 6 below; it is essentially being shaved off by plow blades, most notably at the start and end of the raised hardened centerlines.

Figure 6: Damage on the raised hardened centerline at Fremont Ave N & 42nd Ave N

- Through City staff feedback and observations, the raised hardened centerlines have seen concrete damage due to snowplow blades running along or on top of the centerline causing chipping and scraping of the concrete.

- Raised hardened centerlines should no longer be used due to user safety concerns for people walking and driving.
    - Existing raised hardened centerlines along Fremont Ave N and Grand Ave S have been modified to include yellow paint along the top of the curb to help improve visibility. These locations should continue to be monitored.

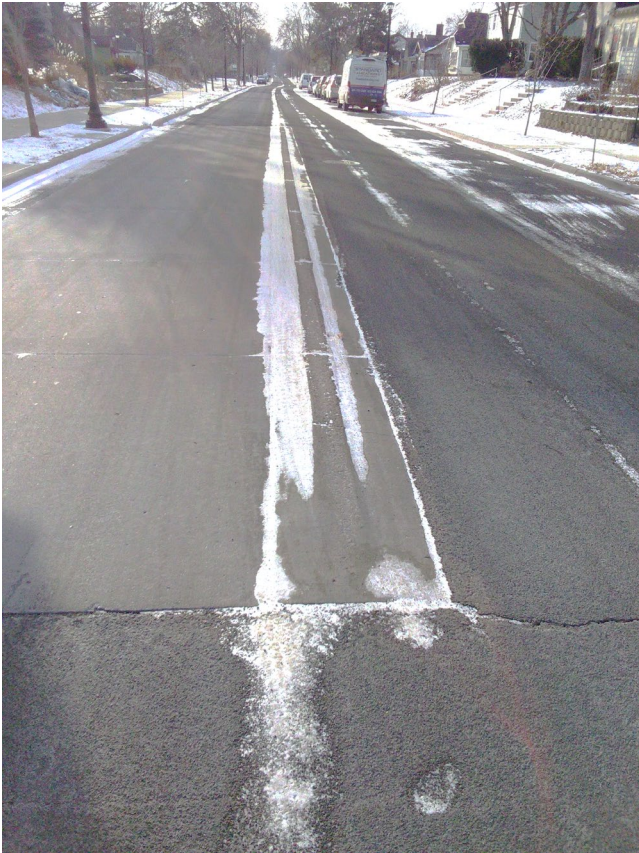
- Snowplow blades consistently run on top of the raised hardened centerline which causes a strip of snow left behind on either side which can lead to visibility issues.

- Snowplow blades ride up over the raised hardened centerline, leaving a small strip of snow that can't be cleared, shown in Figure 7 below; this can lead to visibility challenges of the raised hardened centerline in wintertime, also noted in the comments received through 311 and emails to City staff.

Figure 7: Remanent snow alongside raised hardened centerline after snow clearing

- Through public feedback received via 311 data and emails to City staff, the visibility of raised hardened centerlines can be challenging during winter months when snow builds up. This can create hazards for people walking and driving.
