CPED STAFF REPORT

HPC Agenda Item #6
July 14, 2015
BZH-28248

Project Name: 404 West Broadway and 410 West Broadway

SITE OBSERVATION REPORT

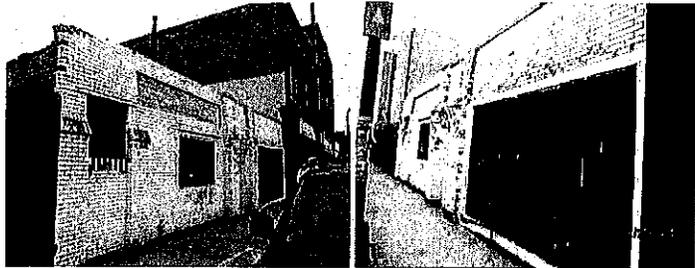
Front Elevation

1. Several areas of the glazed brick on the front wall have lost their glazing and mortar joints. This has predominantly occurred at the upper half of the wall elevation. Open mortar joints allow water infiltration which deterioration of the wall from the inside as well as spalling of the brick and additional mortar during freeze/thaw cycles.

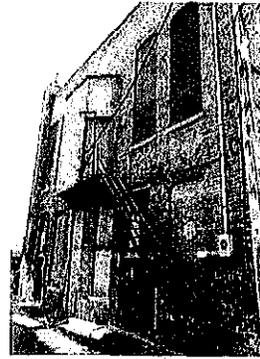
View from northwest corner

1. Several locations on the south elevation require stucco and brick repair.
2. Brick at the northeast corner appears to have experienced major deterioration along with an unprofessional repair.
3. The fire escape stair extending down from the second floor along the rear wall is loosely connected to the building and structurally unstable.
