## 10. Public Safety

### CPTED Scan

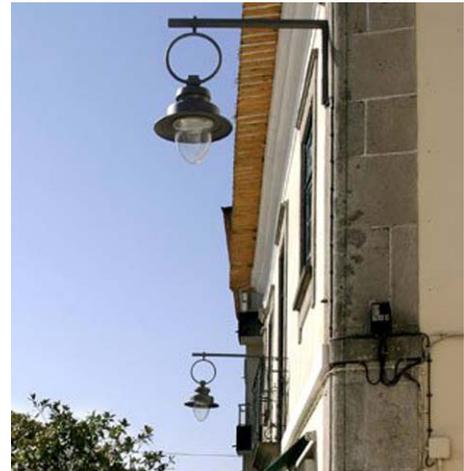
Public spaces should have clear sight lines, and should be visible from private spaces. A common natural surveillance strategy is to ensure that buildings have adequate window coverage facing a public sidewalk. A second strategy is to minimize hiding places, such as dead-end alleys or other places that are removed from view. A third strategy is to light places when it’s dark.

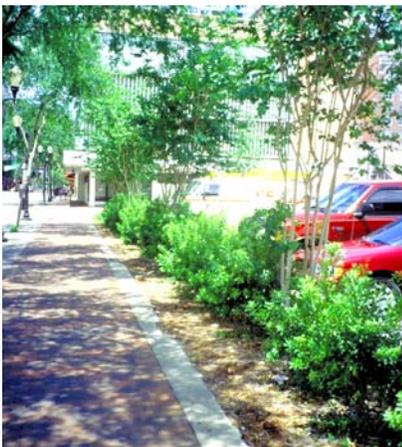
Boundaries between public and private space should be clearly defined, using design elements such as retaining walls or hedges.

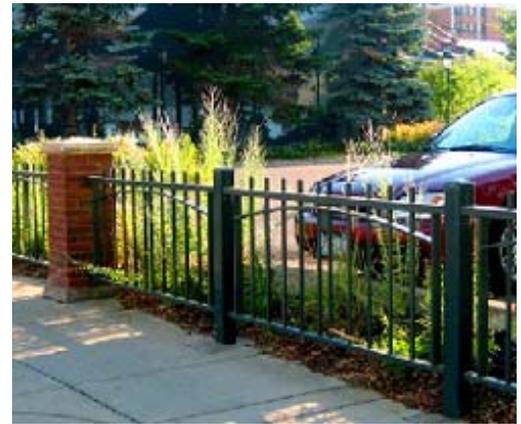
Landscaping elements such as fences and gates restrict access to private property while providing visual interest.

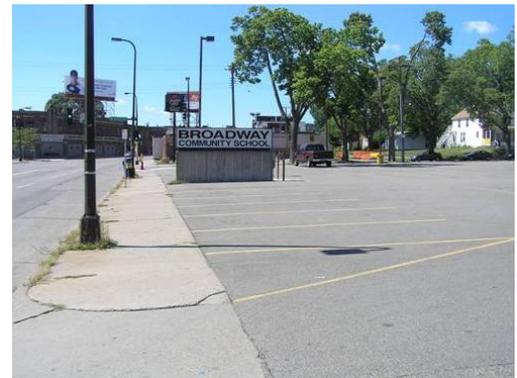
### Broadway School

The sheer size of the parking lot at Broadway School makes it difficult to monitor. Additionally, it lacks features that visually reinforce the distinction between public space (the sidewalk) and private space (the parking lot). Adding landscaping between the sidewalk and the parking lot,

with a low decorative fence or hedge, would direct pedestrian activity to the sidewalk rather than the parking lot, creating a sense of predictability. In the long term, redevelopment of the site, or its West Broadway edge, would do more to generate legitimate and positive traffic at the street, and contribute to the natural surveillance of the site.

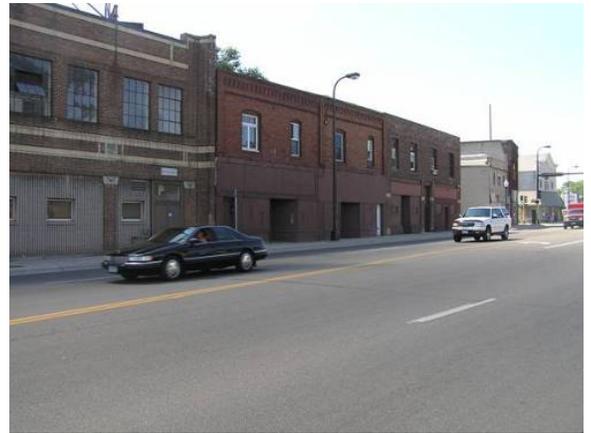
### The Curve

Several properties on the south side of West Broadway between Girard Ave N and Logan Ave N feature long stretches of blank walls or boarded windows. When combined with the curvilinear street pattern and lower volumes of foot traffic, pedestrians along this stretch feel isolated and unsafe.

While some of these properties may be redeveloped in the future, a few short-term improvements would substantially improve the sense of safety for pedestrians in this area. Improvements could include replacing boarded windows on the block between Girard and Irving and installing windows on the West Broadway-facing side of Checker Auto Parts. If the YMCA remodels or expands its building between Knox and Logan Avenues, it should explore options for improving natural surveillance along West Broadway where there is currently a blank wall.
